Marshfield Pool Study Committee

Site Assessment - Hefko Pool

Site Analysis - Hefko Pool

Marshfield Hefko Pool Analysis
September 14, 2016Site Discussion:

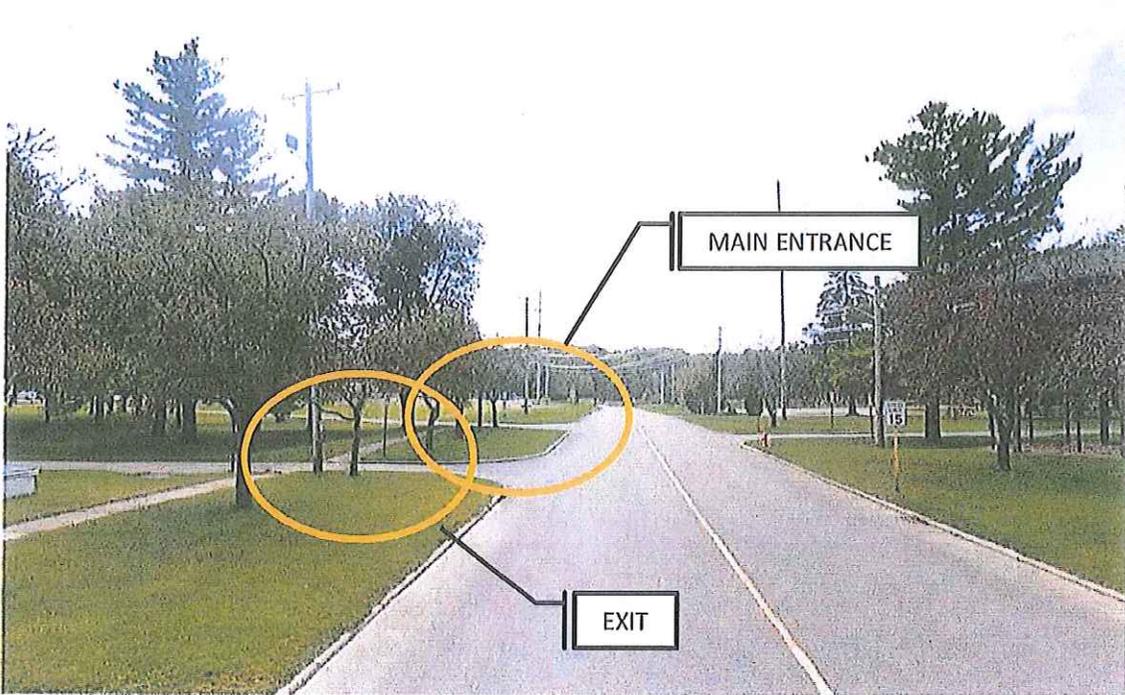
Site Image 1: Site Access from Roddis Avenue

- The entry and exit drives off Roddis Avenue are poorly marked and easy to miss. We suggest adding additional signage at the entry drive. (see Site Image 1)

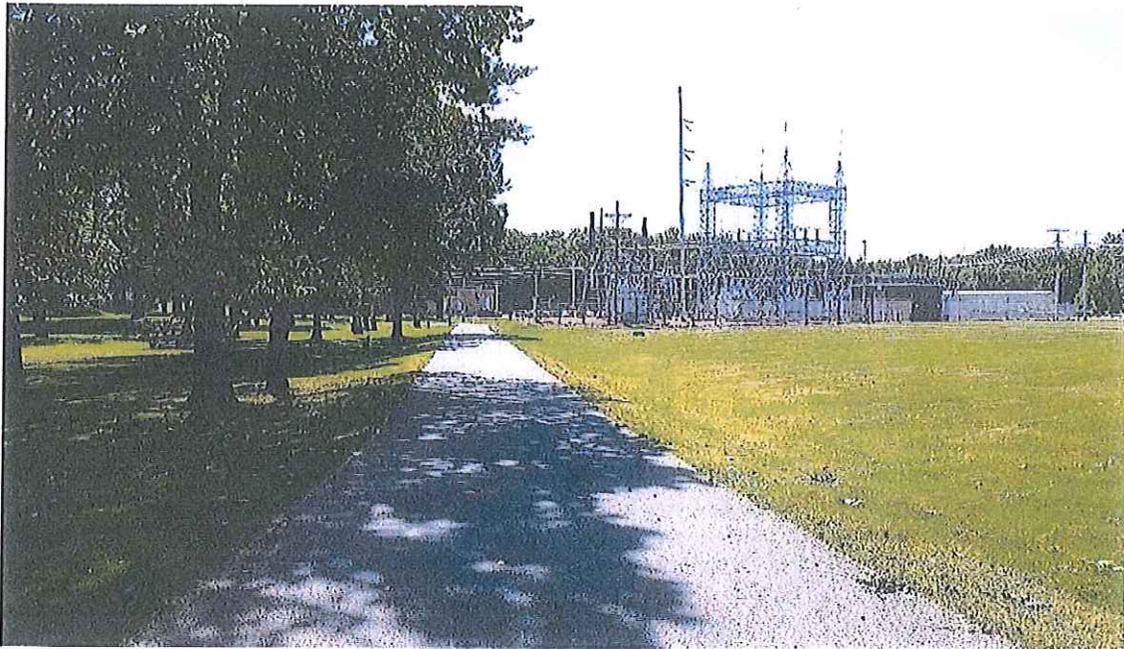
Site Image 2: Main Entrance Drive off Roddis Avenue

- The long one-way access loop road is oddly placed and unnecessary, resulting in extra maintenance costs. (see Site Image 2)
- The parking lot is undersized and in worn condition. Approximately 44 parking stalls are currently provided. Industry standards suggest 140-300 stalls should be provided for a facility of this size (800 patron capacity). (see Site Image 3)

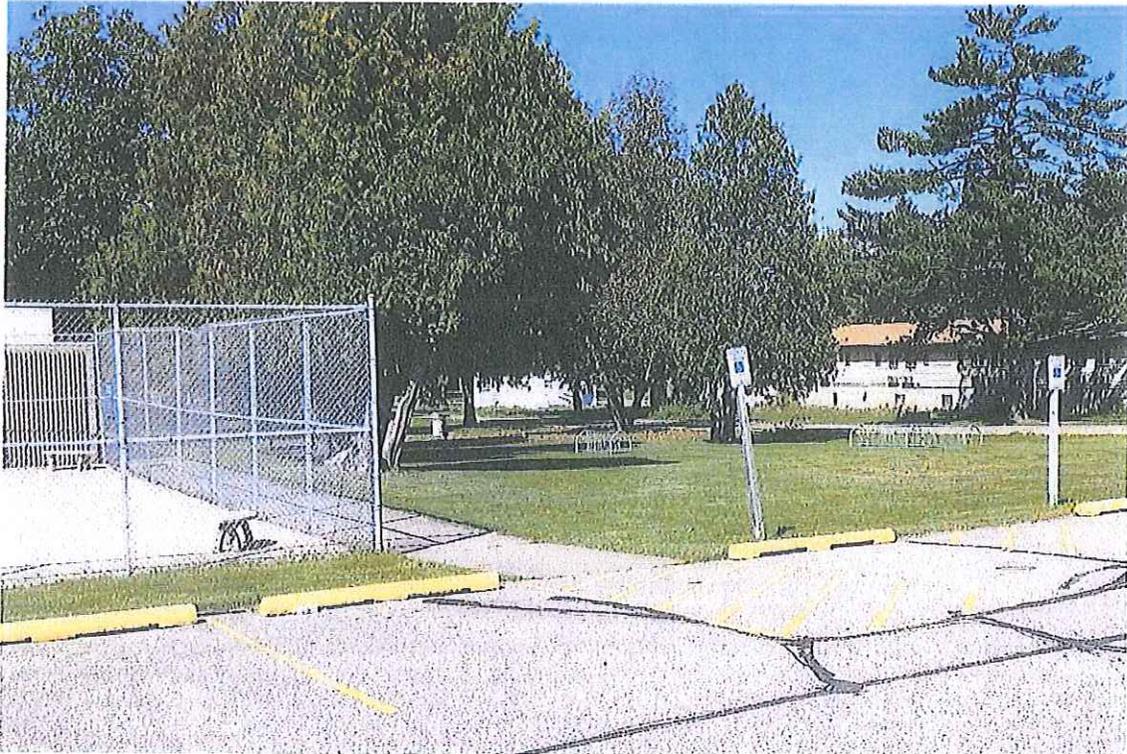
Site Image 4: Accessible Parking and Main Entrance to Pool Facilities

- Parking is spread out, increasing walking distance to pool building.
- Bike parking located in grassy areas, not on a hard surface or pavement.
- The pool building entrance is not inviting and has poor sight lines. (see Site Images 4 & 5)

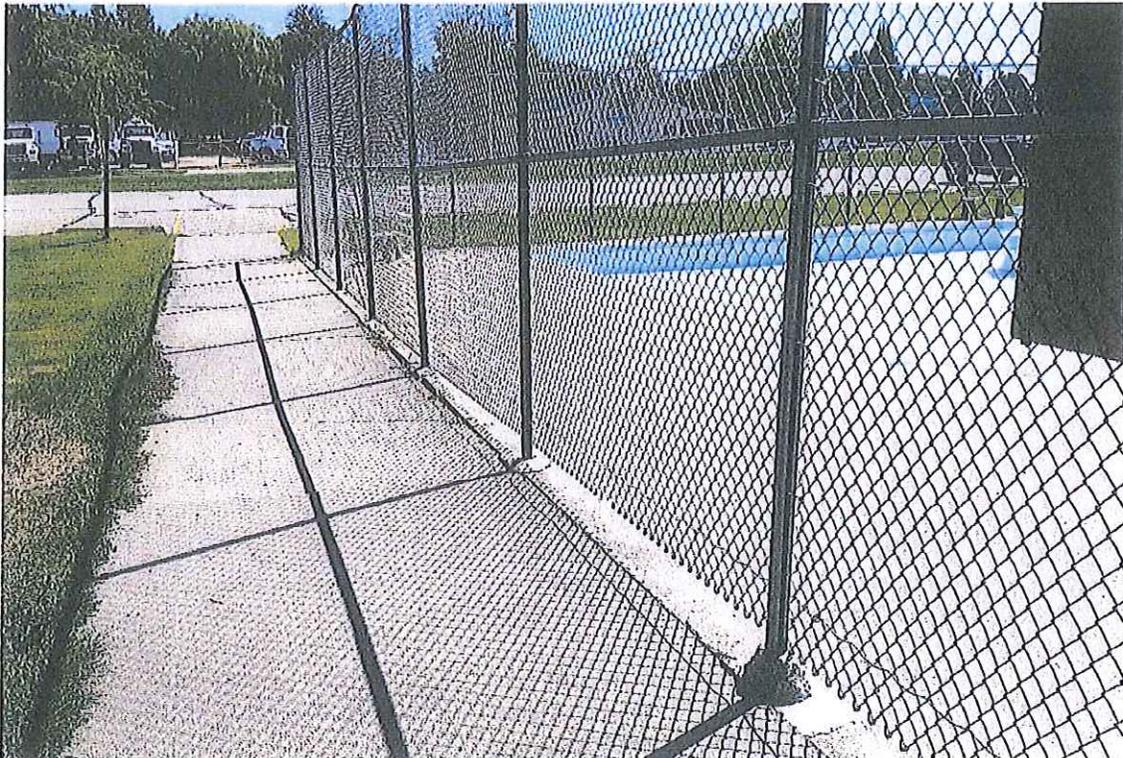
Site Image 6: Pool Enclosure Perimeter Fence & Main Entrance Walk

- The pool enclosure perimeter fencing is worn and bent, with posts heaving out of the ground. (see Site Image 6)
- The interior fence within the pool enclosure has non-compliant latches.

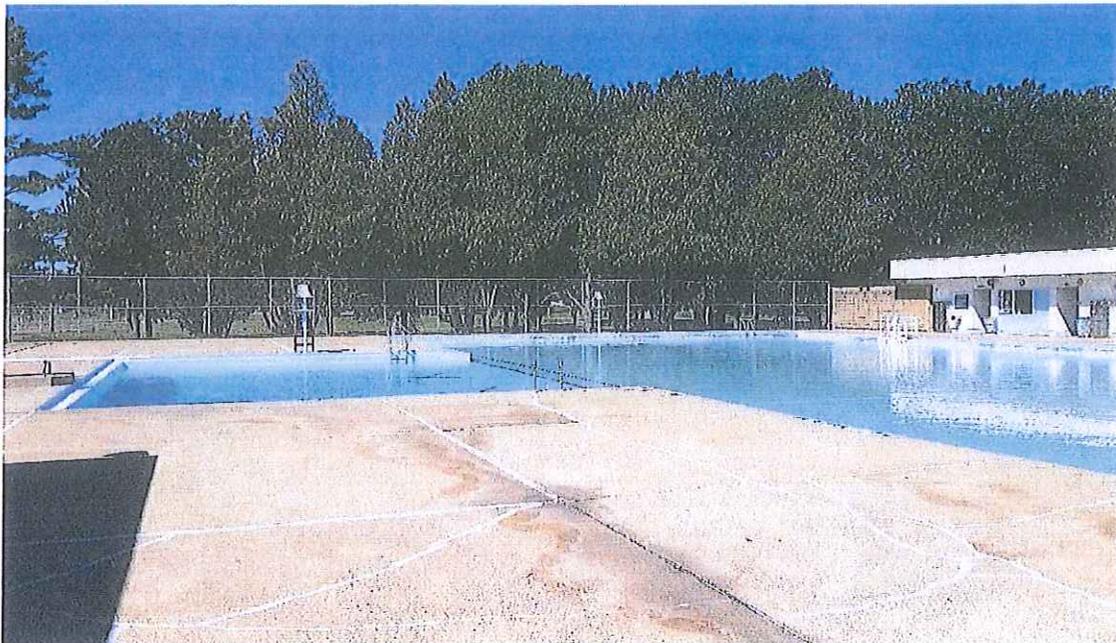
Site Image 7: Diving Well and Main Pool

- There is significant cracking and heaving of the concrete pool deck. Some of these settlement cracks are a tripping hazard. (see Site Images 7, 8, & 11)
- The pool vessels and deck have been repaired and patched in numerous locations.
- No shade is provided within the pool enclosure.
- The exterior drinking fountain is not ADA compliant. (see Site Image 12)
- ADA access to the main pool is inadequate.
- The baby pool water feature is a climbing hazard. (see Site Image 10)
- There are poor sight lines between the baby pool and main pool areas.
- There is inadequate visibility of the entire pool facility from within the pool house – there is no visibility of the baby pool area.

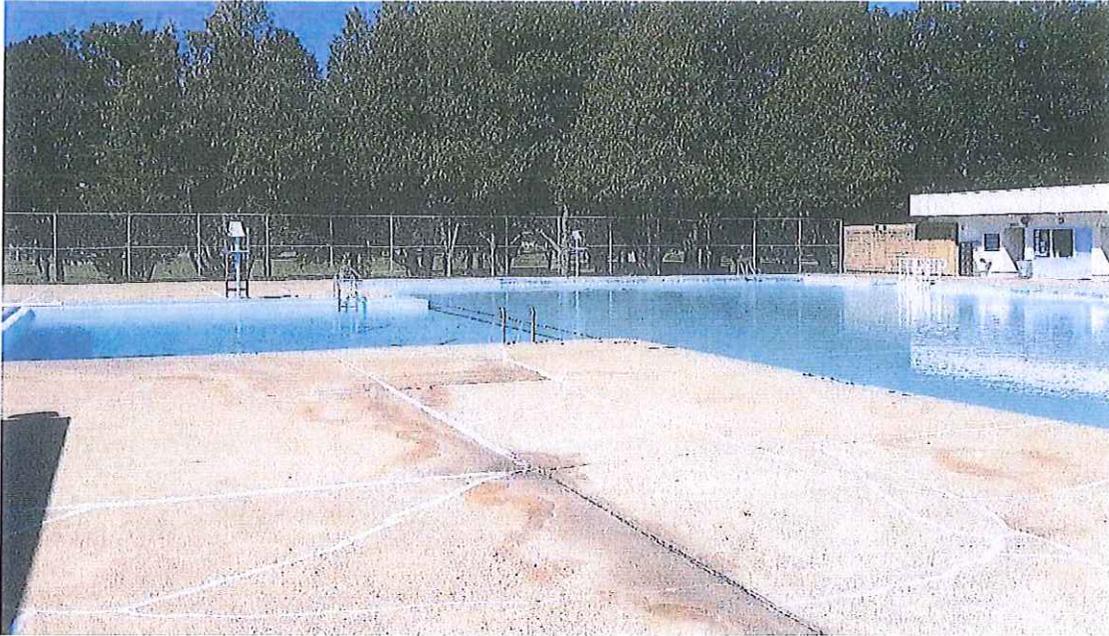
Site Image 11: Cracked Pool Decking

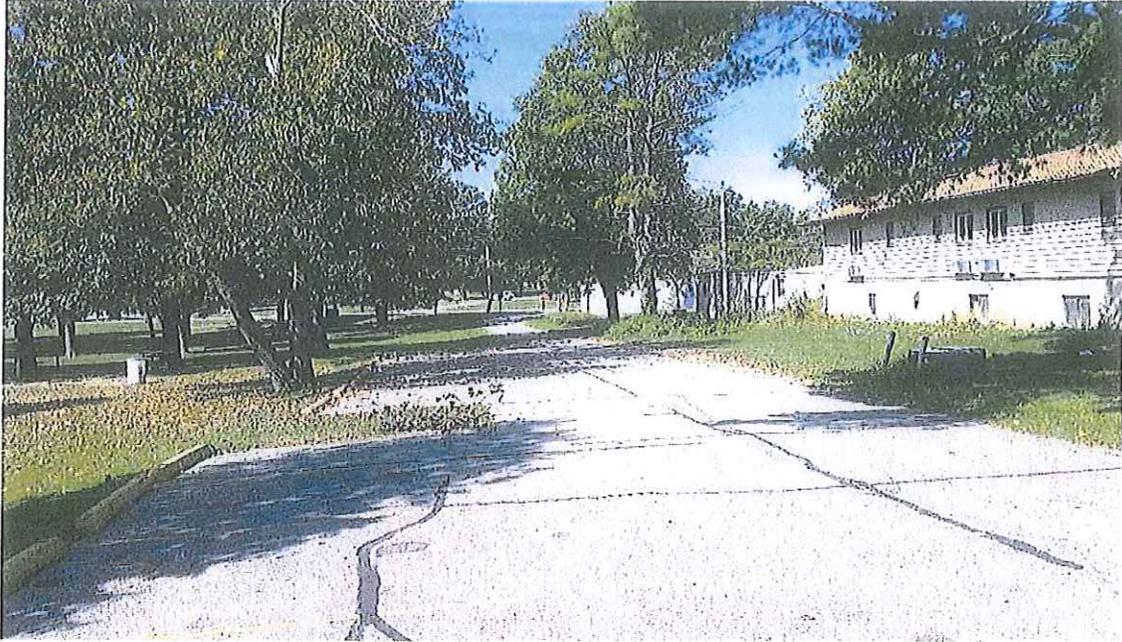
Site Image 15: Exit Drive & Adjacent Buildings

- There is no separation between the park/pool facility and adjacent motel. We suggest adding a physical or vegetative barrier to limit disturbance to the motel clientele. (see Site Image 15)

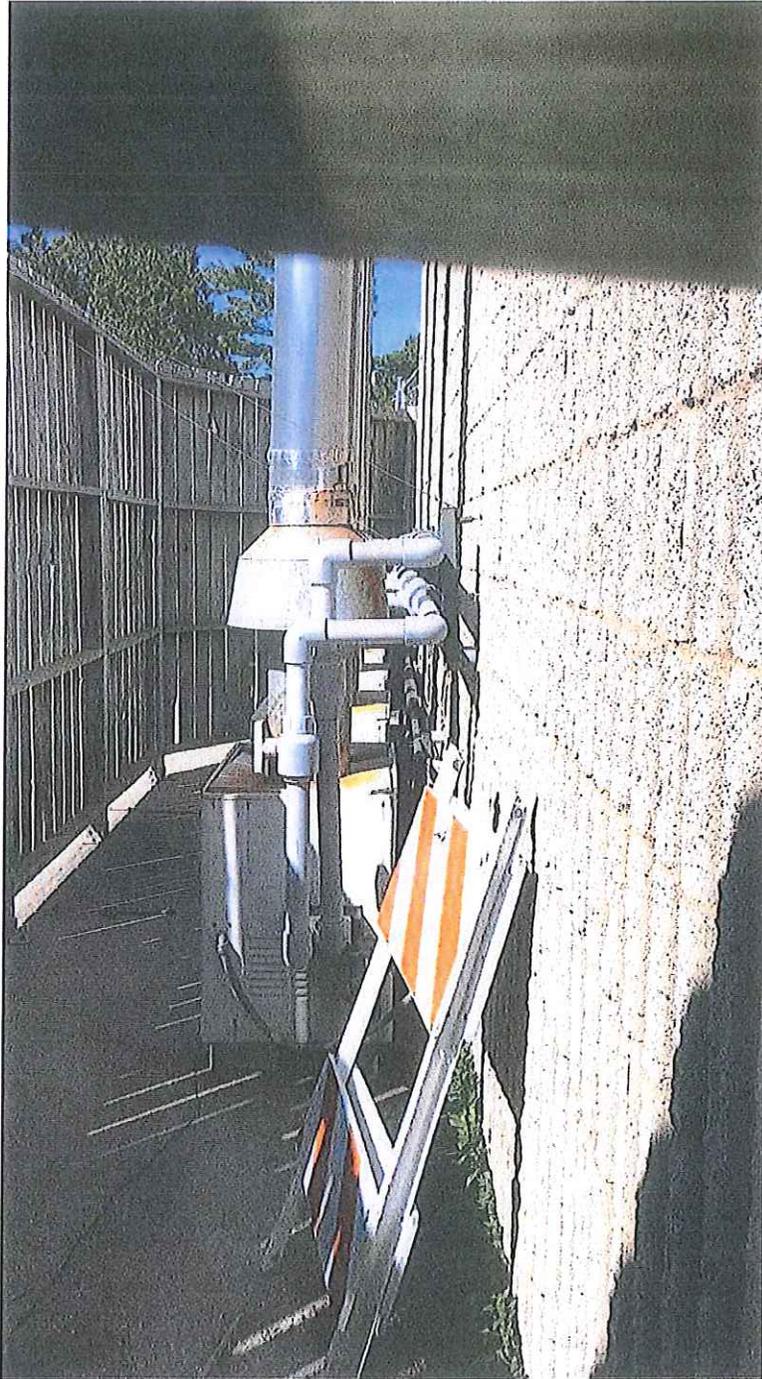
- The pool heater is heated by four exterior mounted water heaters that are well aged and should be replaced with any remodel work.
- The pool circulation system does not meet current pool code. Water from the wading pool is able to mix with water from the main pool vessels which violates the current pool code. Each water vessel must have a separate dedicated filtration loop and cannot be allowed to cross-contaminate per code.

Building Image 1: Exterior Pool Heaters

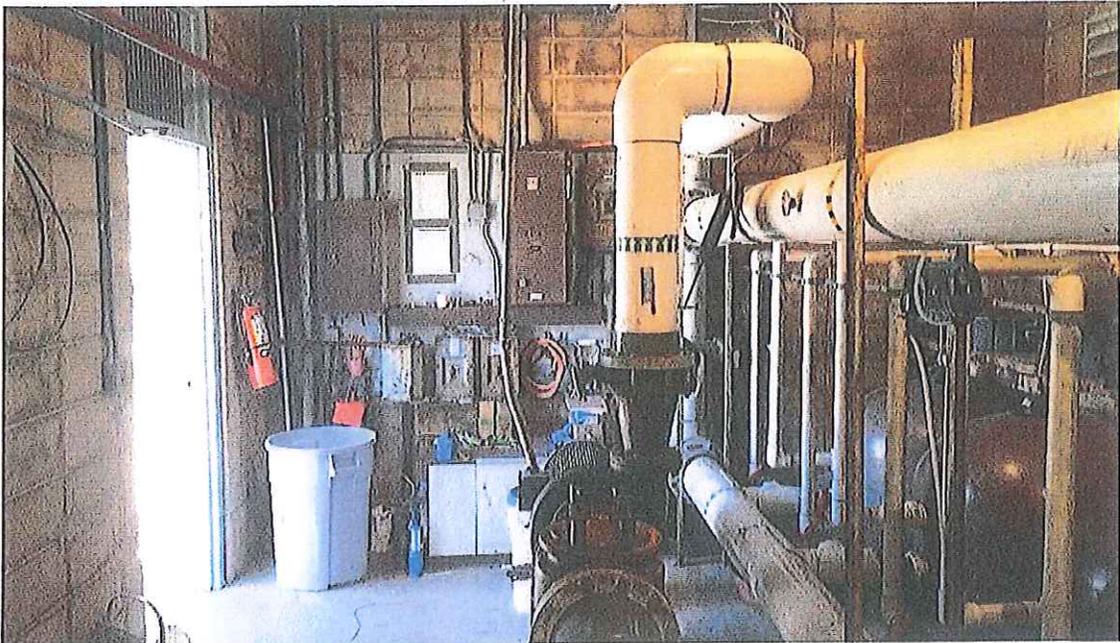
Building Image 3: Pool Mechanical House - Interior

- Water Heater: The domestic water heater is located in the pool house and appears to be in relatively decent condition.
- The copper water service and sanitary waste piping in the pool mechanical room is heavily corroded and will need to be replaced (see Building Images 3 & 12).

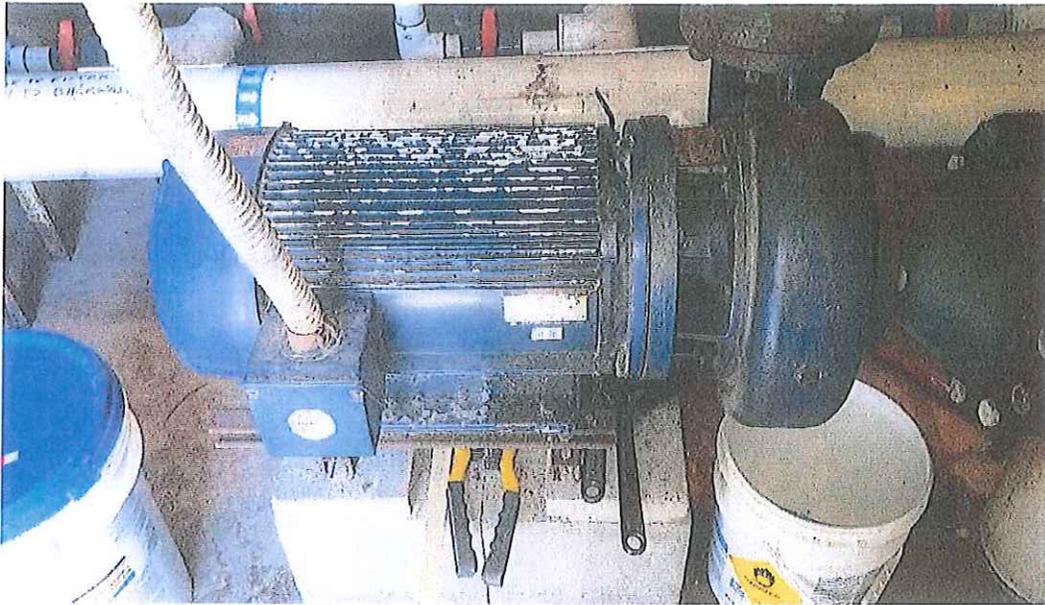
- The main pool pump is heavily corroded and at the end of its lifespan. It will need to be replaced in the near future.
- The main pool and baby pool vessels have not exhibited water leaking and cracking to any significant degree, however they are 42 years old and are nearing the end of their serviceable life.

Building Image 4: Main Pool Pump

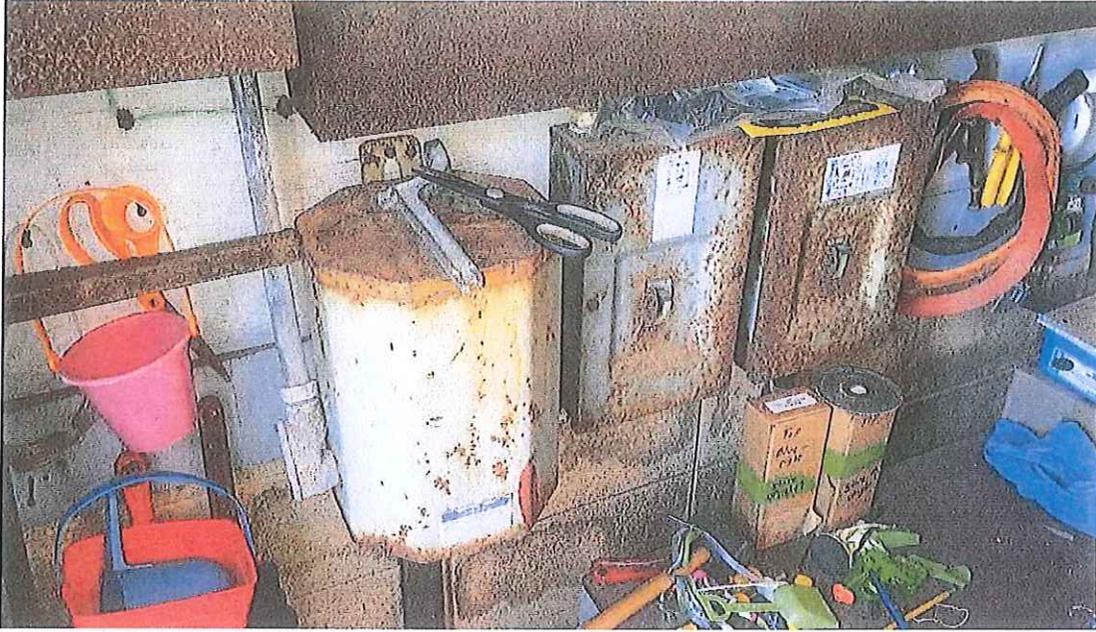
- Several of the electrical panels in the pool mechanical room are severely rusted and constitute a safety hazard (see Building Image 6).
- The pool filtration system consists of multiple residential grade filters ganged together in parallel to serve the main pool. These filters are not intended for commercial pool use and should be replaced with commercial grade sand filters as part of any remodel work.

Building Image 6: Electrical Power Panel

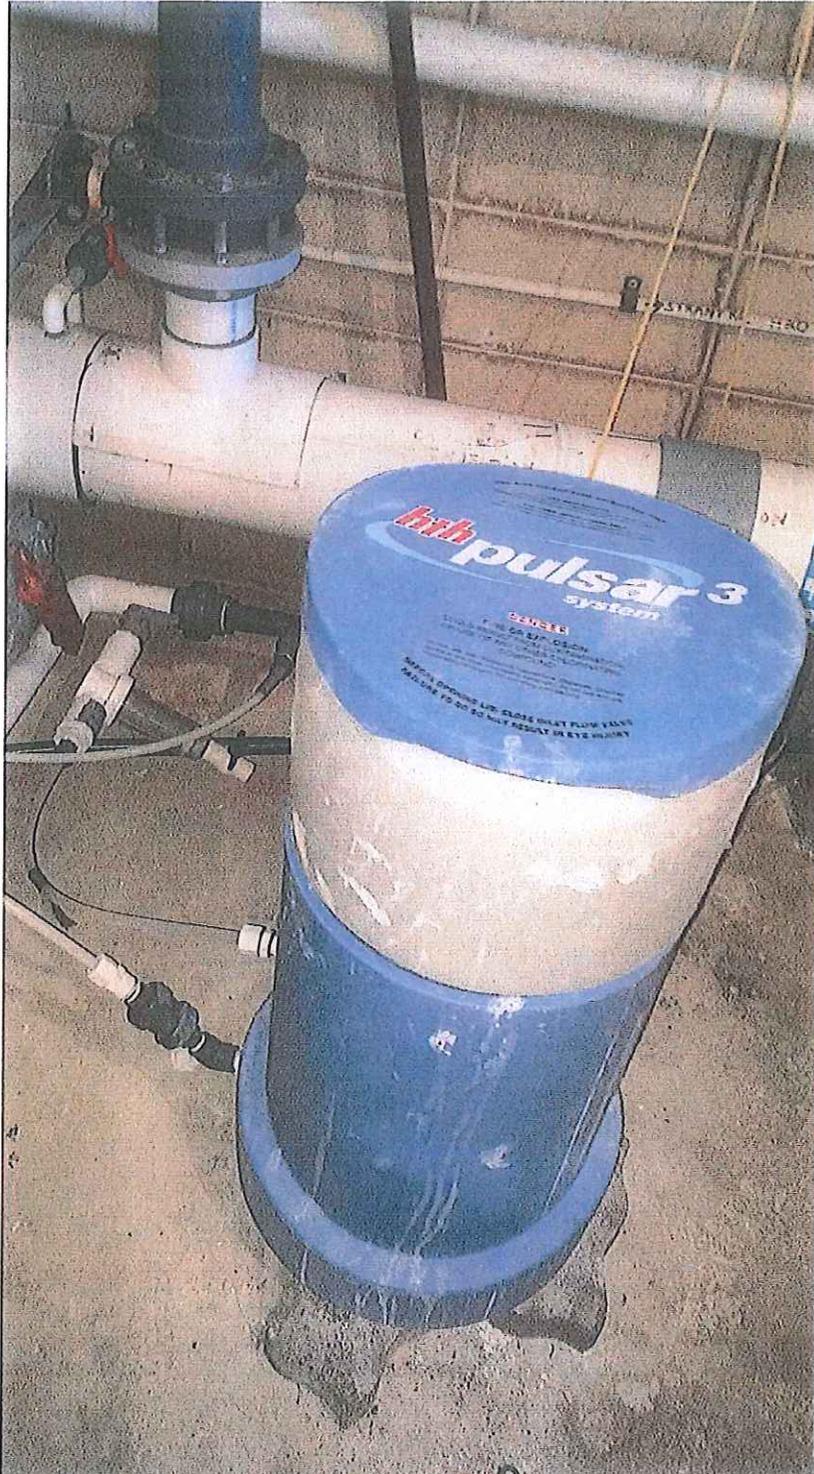
- The pool controller and Pulsar chlorination units are new and have a long serviceable life ahead of them, however upgrading the chlorination system to a larger unit will be required if the pool is remodeled.

Building Image 7: Pulsar Chlorine System

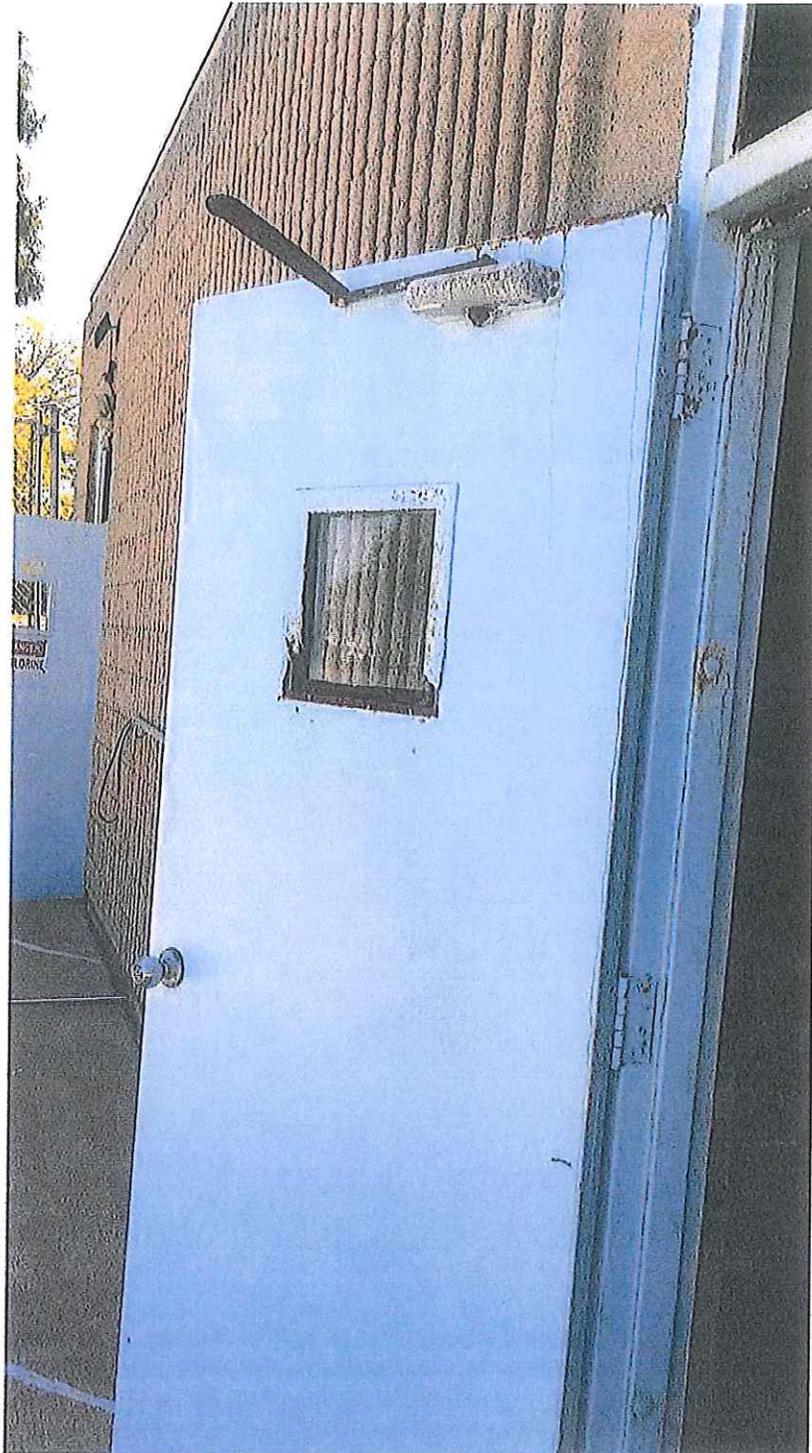
Building Image 8: Pool Equipment Building Door

- Exterior Doors: Some exterior door frames are rusted and should be replaced (see Building Image 8). In general, the doors, door frames, and door hardware should be replaced as part of any future remodel work.

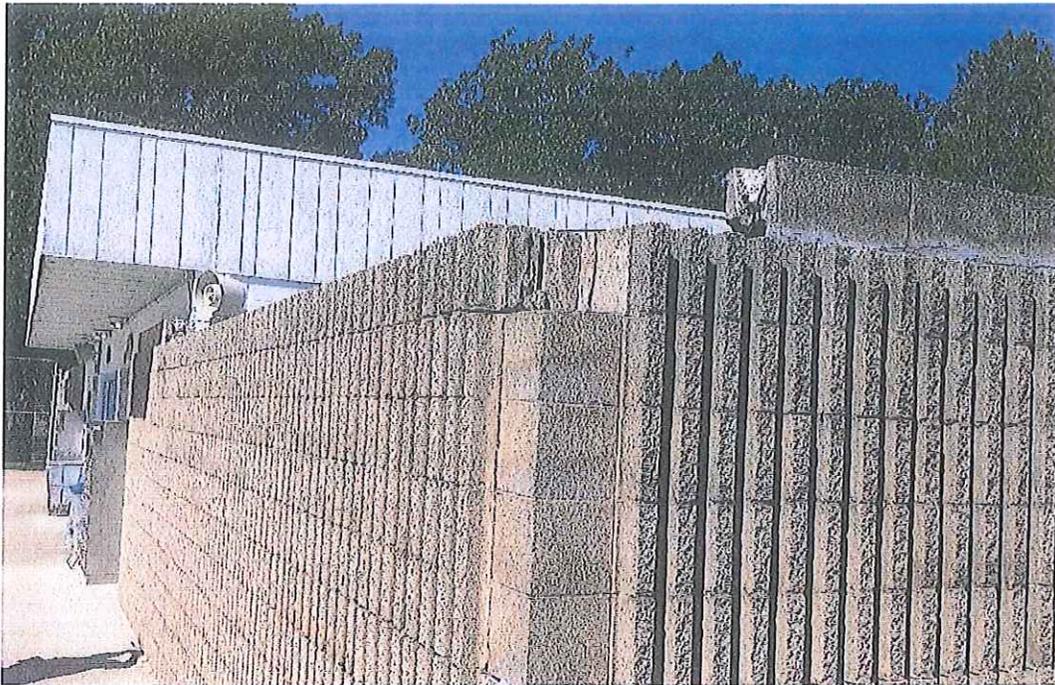
- Exposed CMU block at the exterior changing areas have been significantly damaged and in many locations, the top course of masonry is missing. There are also several areas where the cmu block has cracked indicating settlement movement. Any repair/replacement work for the cmu would require, at a minimum, tuck pointing, replacement of the cmu top course, and flashing of the top of wall to prevent water intrusion into the wall.

Building Image 9: Pool House Changing Room Walls – Damaged CMU

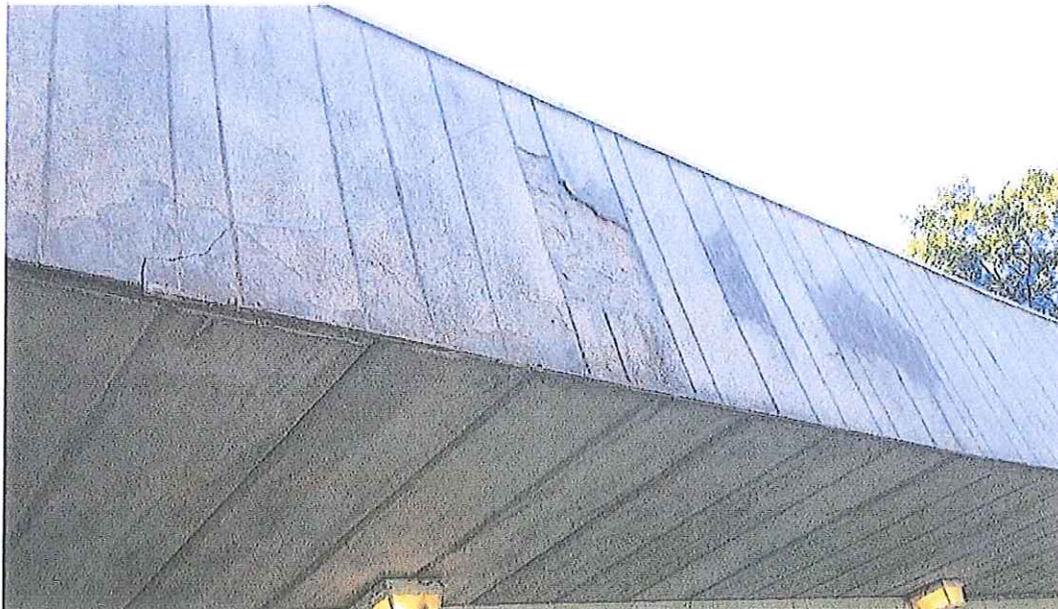
Building Image 10: Exterior Pool House Façade

- The exterior fascia is corroded in many locations as well as cracked and deteriorated. This fascia should be replaced with any remodel work should the building be left in service.

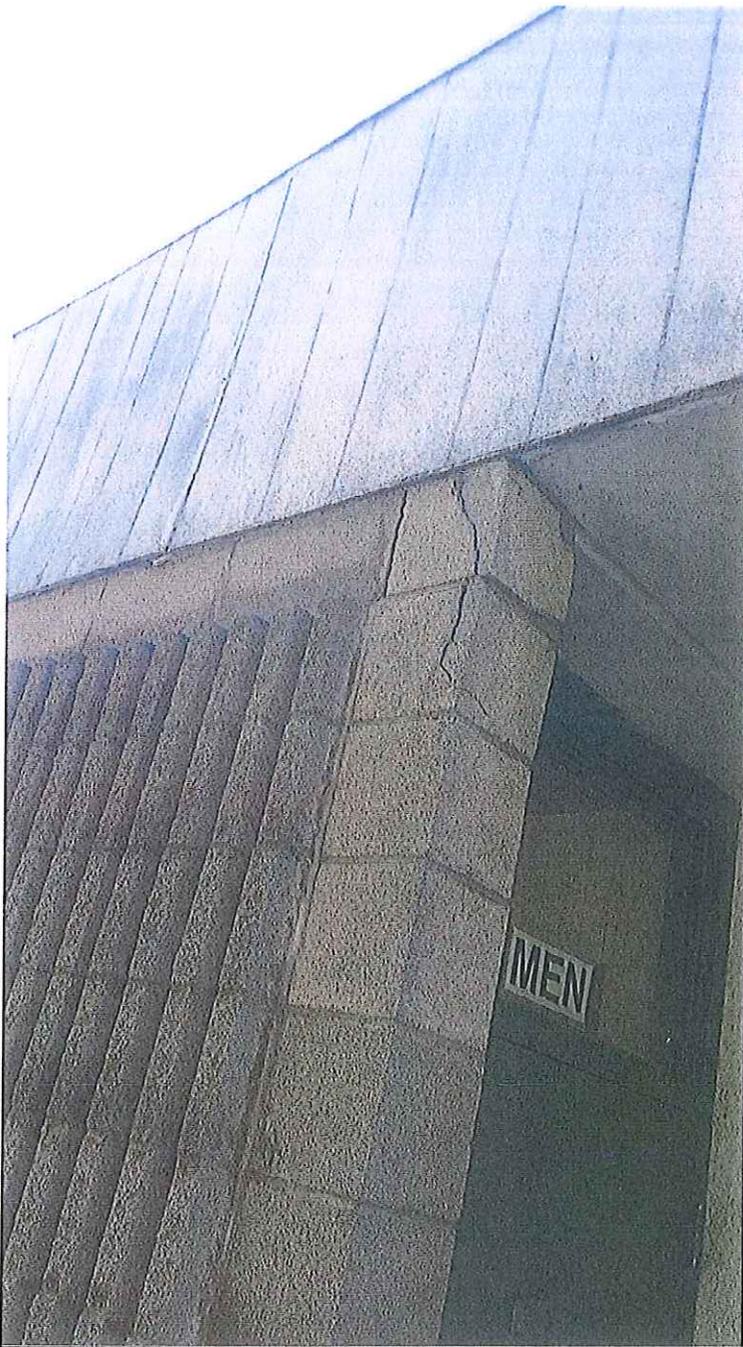
Building Image 11: Damage Masonry at Pool Entrance

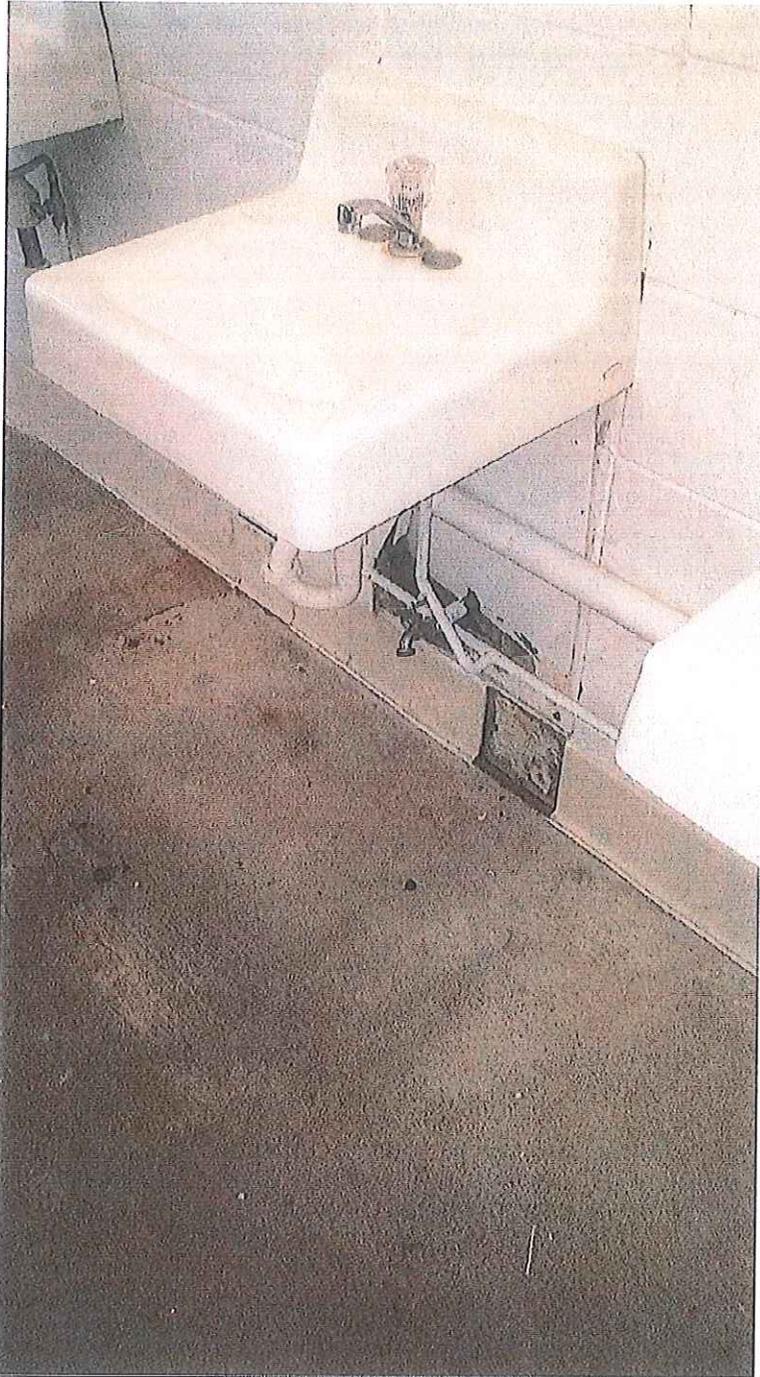
- Plumbing Fixtures: Plumbing fixtures are old and should be replaced with any future remodel. Some damage to the masonry walls exist below lavatories located in the women's restroom.

Building Image 14: Pool House Wall Damage Below Lavatory
