Marshfield Pool Study Committee

Site Assessment - Hefko Pool

Site Analysis - Hefko Pool

Marshfield Hefko Pool Analysis
September 14, 2016Site Discussion:

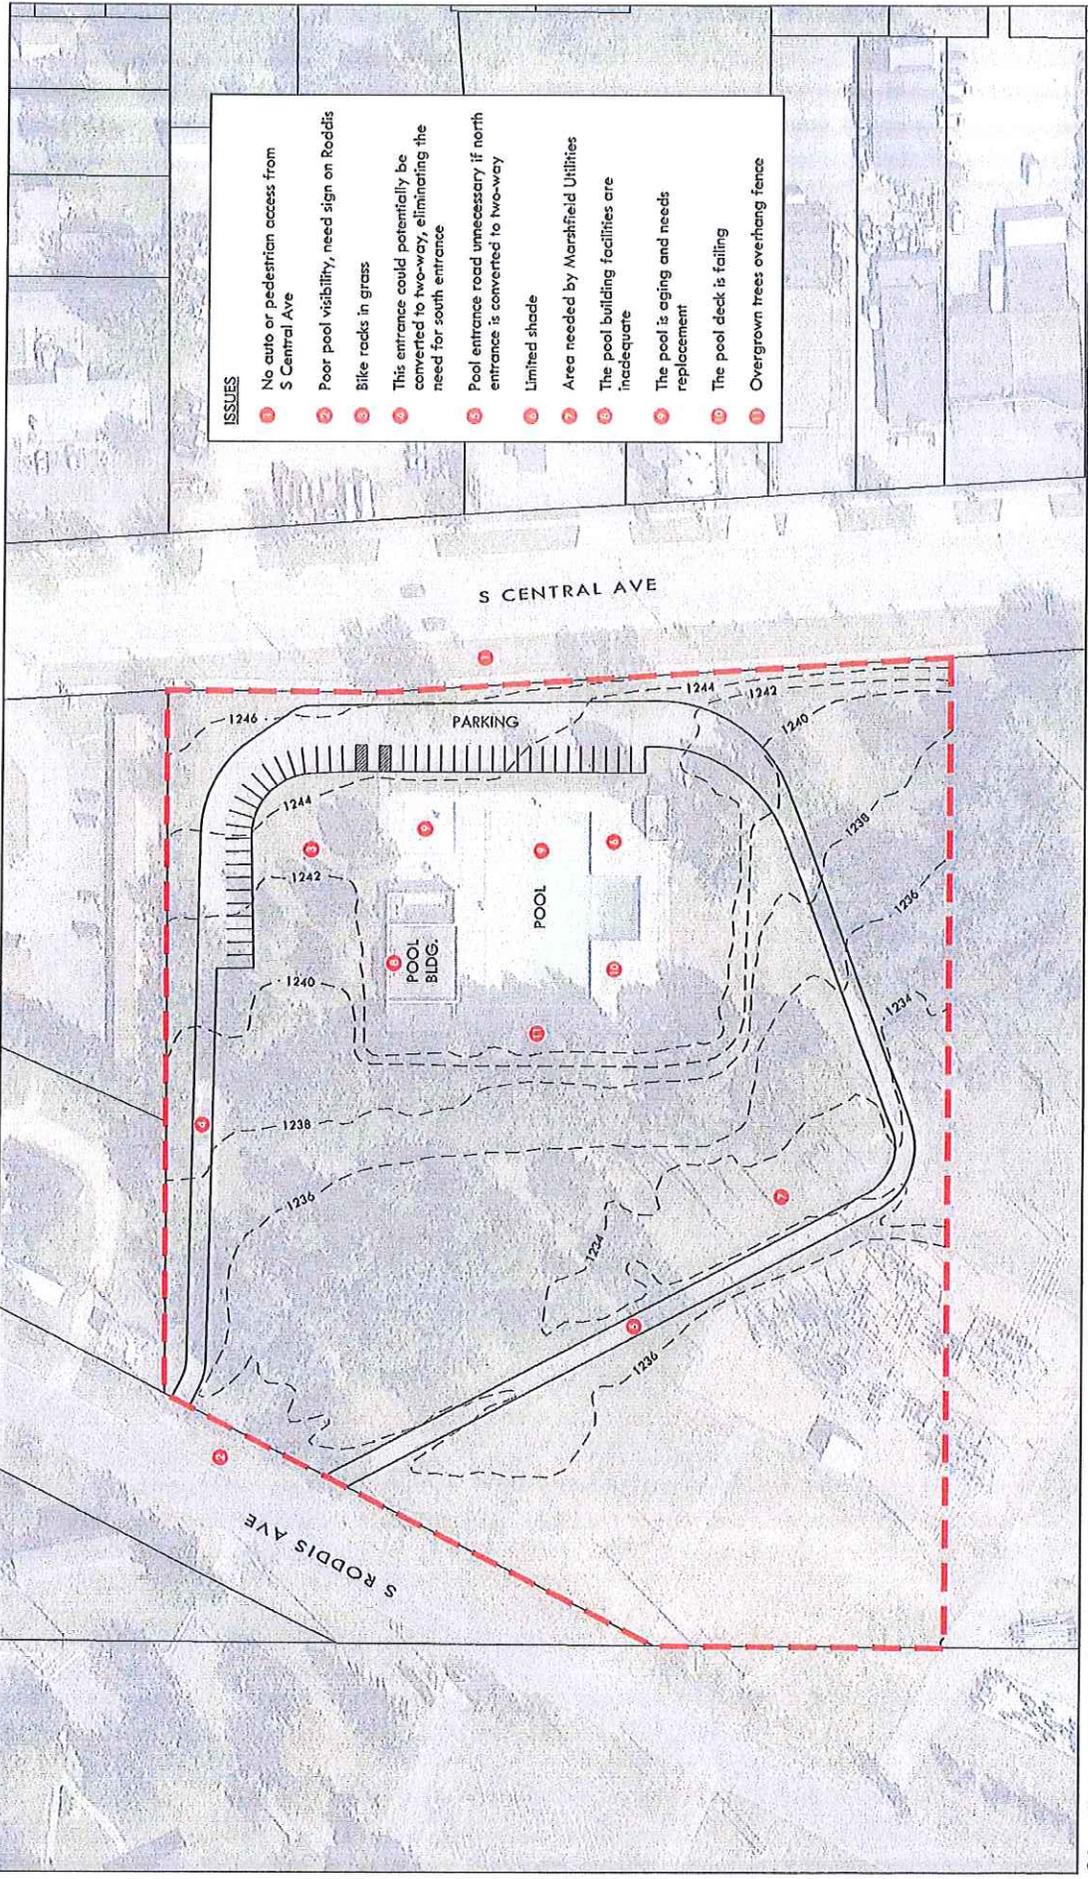
- ISSUES**
- 1 No auto or pedestrian access from S Central Ave
 - 2 Poor pool visibility, need sign on Roddis
 - 3 Bike racks in grass
 - 4 This entrance could potentially be converted to two-way, eliminating the need for south entrance
 - 5 Pool entrance road unnecessary if north entrance is converted to two-way
 - 6 Limited shade
 - 7 Area needed by Marshfield Utilities
 - 8 The pool building facilities are inadequate
 - 9 The pool is aging and needs replacement
 - 10 The pool deck is failing
 - 11 Overgrown trees overhang fence

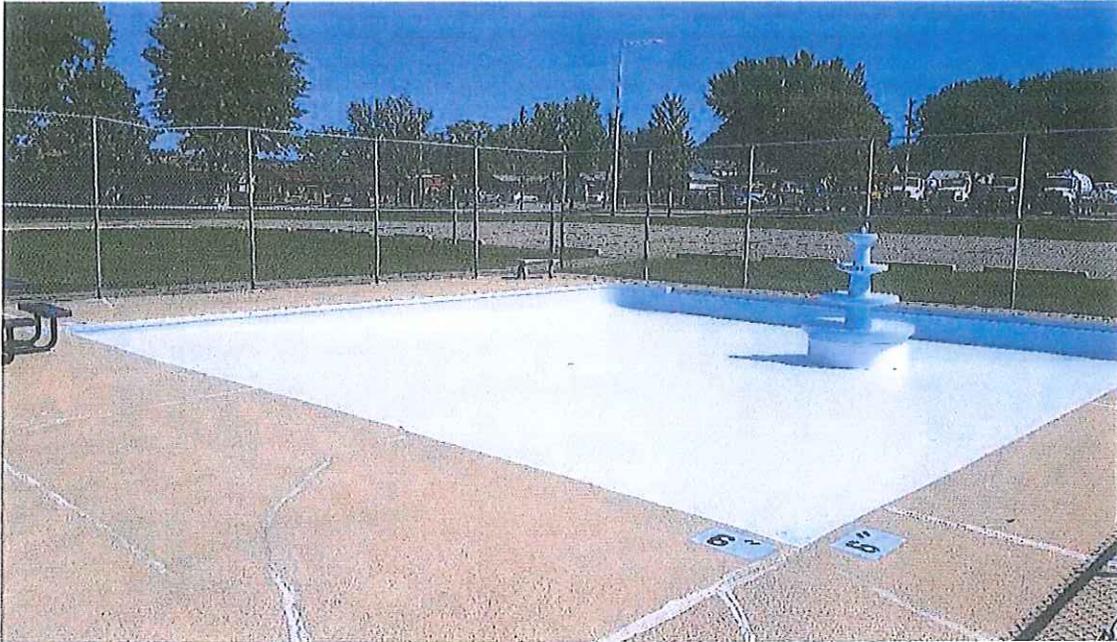
Site Image 9: Baby Pool

- There is significant cracking and heaving of the concrete pool deck. Some of these settlement cracks are a tripping hazard. (see Site Images 7, 8, & 11)
- The pool vessels and deck have been repaired and patched in numerous locations.
- No shade is provided within the pool enclosure.
- The exterior drinking fountain is not ADA compliant. (see Site Image 12)
- ADA access to the main pool is inadequate.
- The baby pool water feature is a climbing hazard. (see Site Image 10)
- There are poor sight lines between the baby pool and main pool areas.
- There is inadequate visibility of the entire pool facility from within the pool house – there is no visibility of the baby pool area.

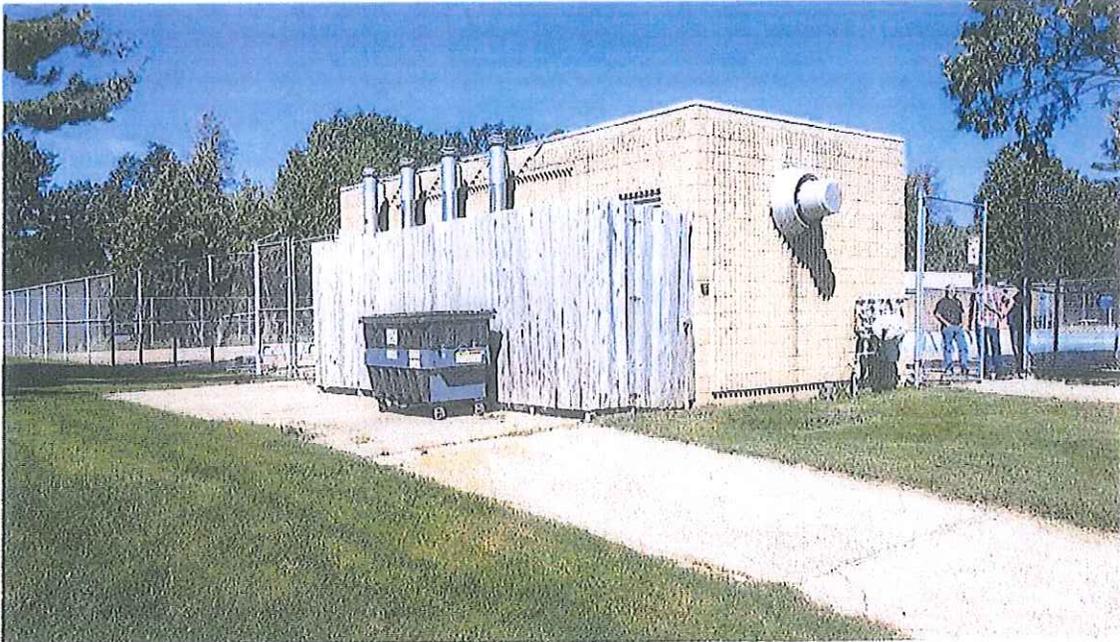
Building Image 2: Pool Mechanical House - Exterior

- In general, the pool equipment building shell is in good condition and may continue to be used in the future. The exterior hollow metal doors are heavily rusted and will require replacement.

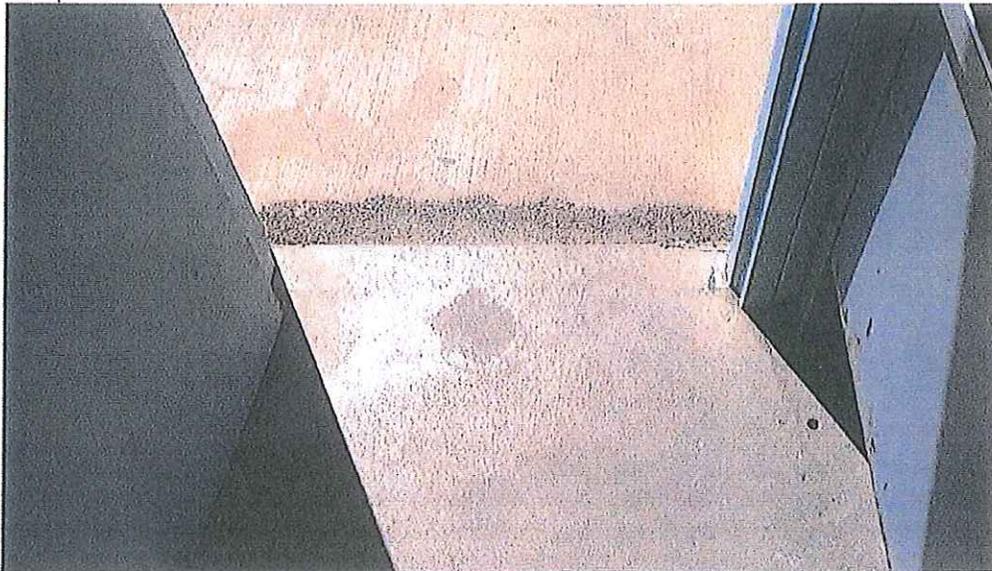
Building Image 13: Pool House to Pool Deck Entry

- Exterior Doors: Some exterior door frames are rusted and should be replaced (see Building Image 8). In general, the doors, door frames, and door hardware should be replaced as part of any future remodel work.
